**Tree Inventory, Assessment
and
Protection Report**

**3036-6062 Woodside Road
Woodside, CA 94062**

July 3, 2028

Richard Gessner

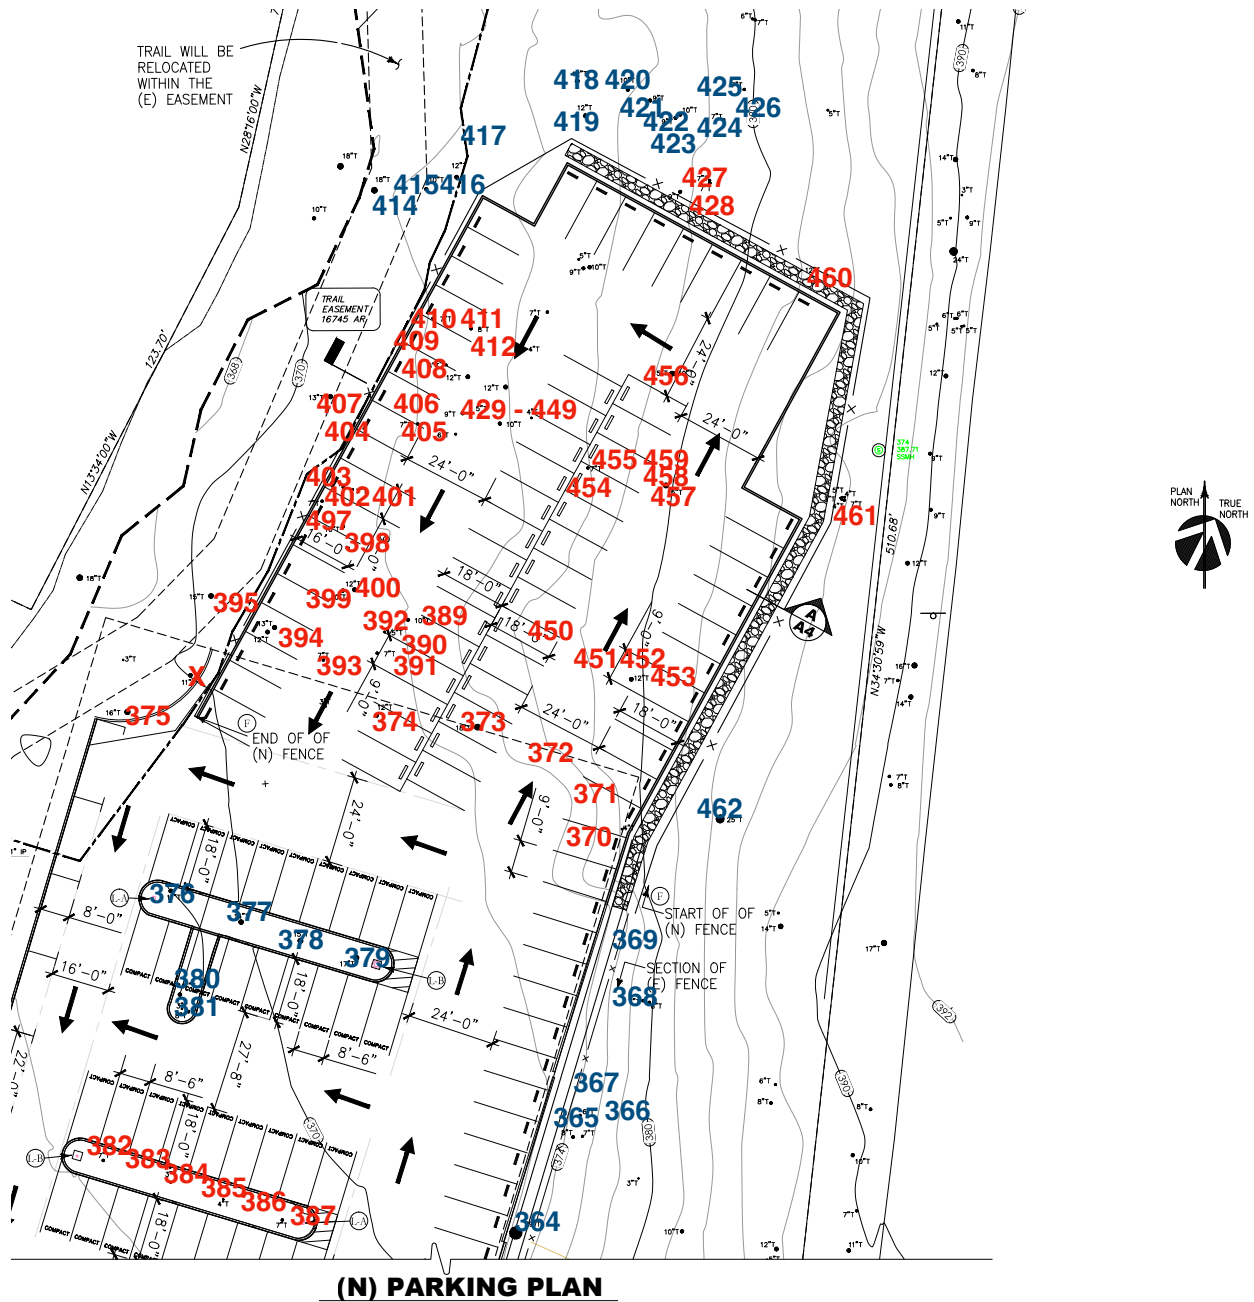
Appendix A: Tree Inventory Proposed Plan and Tree Protection

Trees in “Red” are expected to be removed to accommodate the new parking lot.

2. Place tree protection fence around trees #415 to #426, #376 to #381 that could be affected at a minimum of eight times their trunk diameter distance in radius (calculated tree protection zone) or at the drip line distance, whichever is greater (Appendix A).

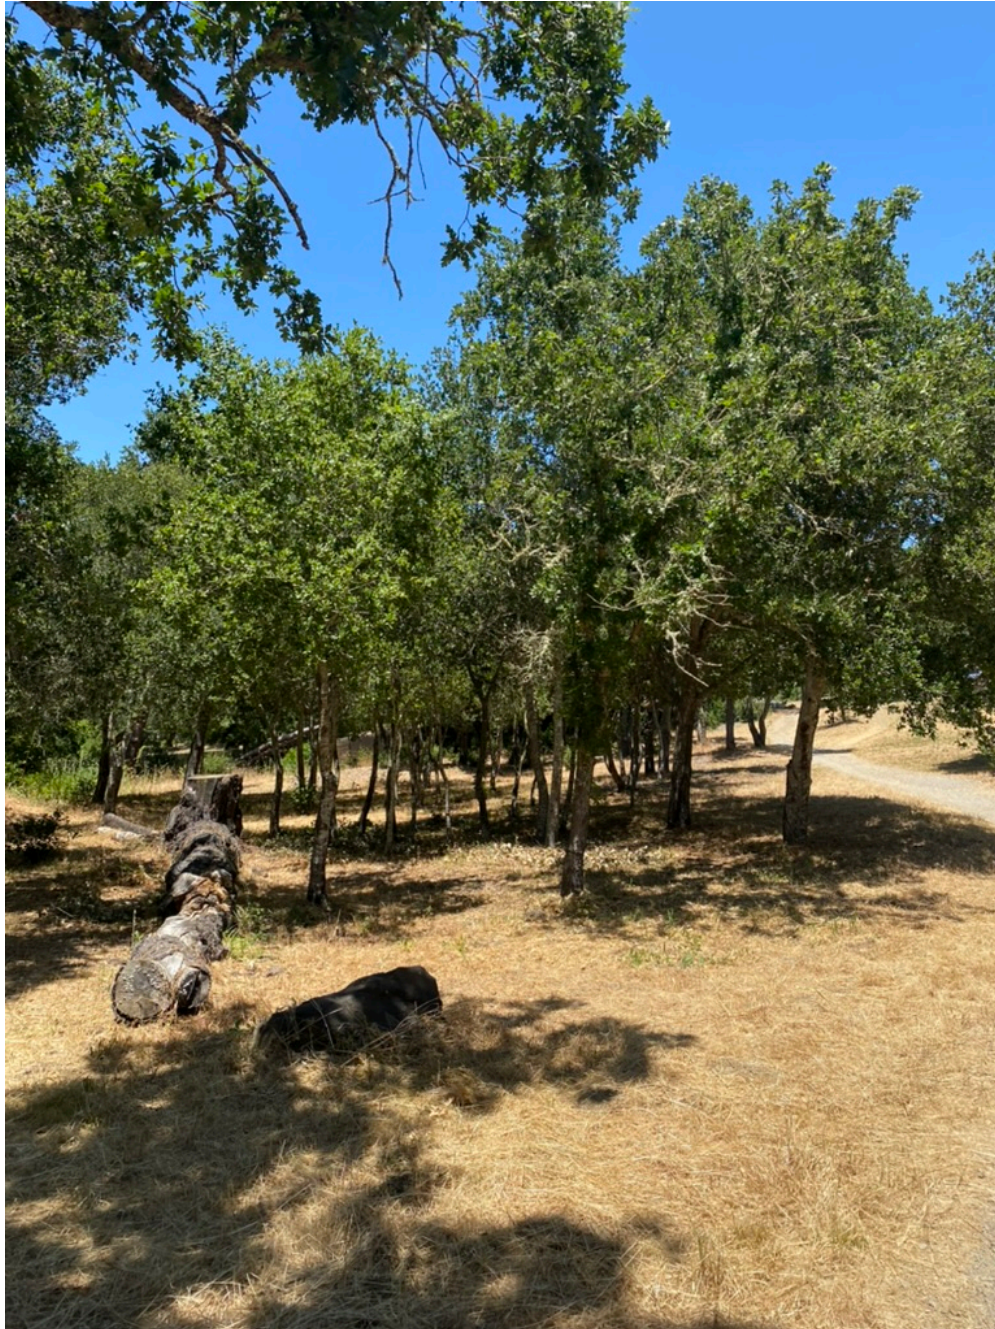
C1: Trees in parking lot footprint to be removed

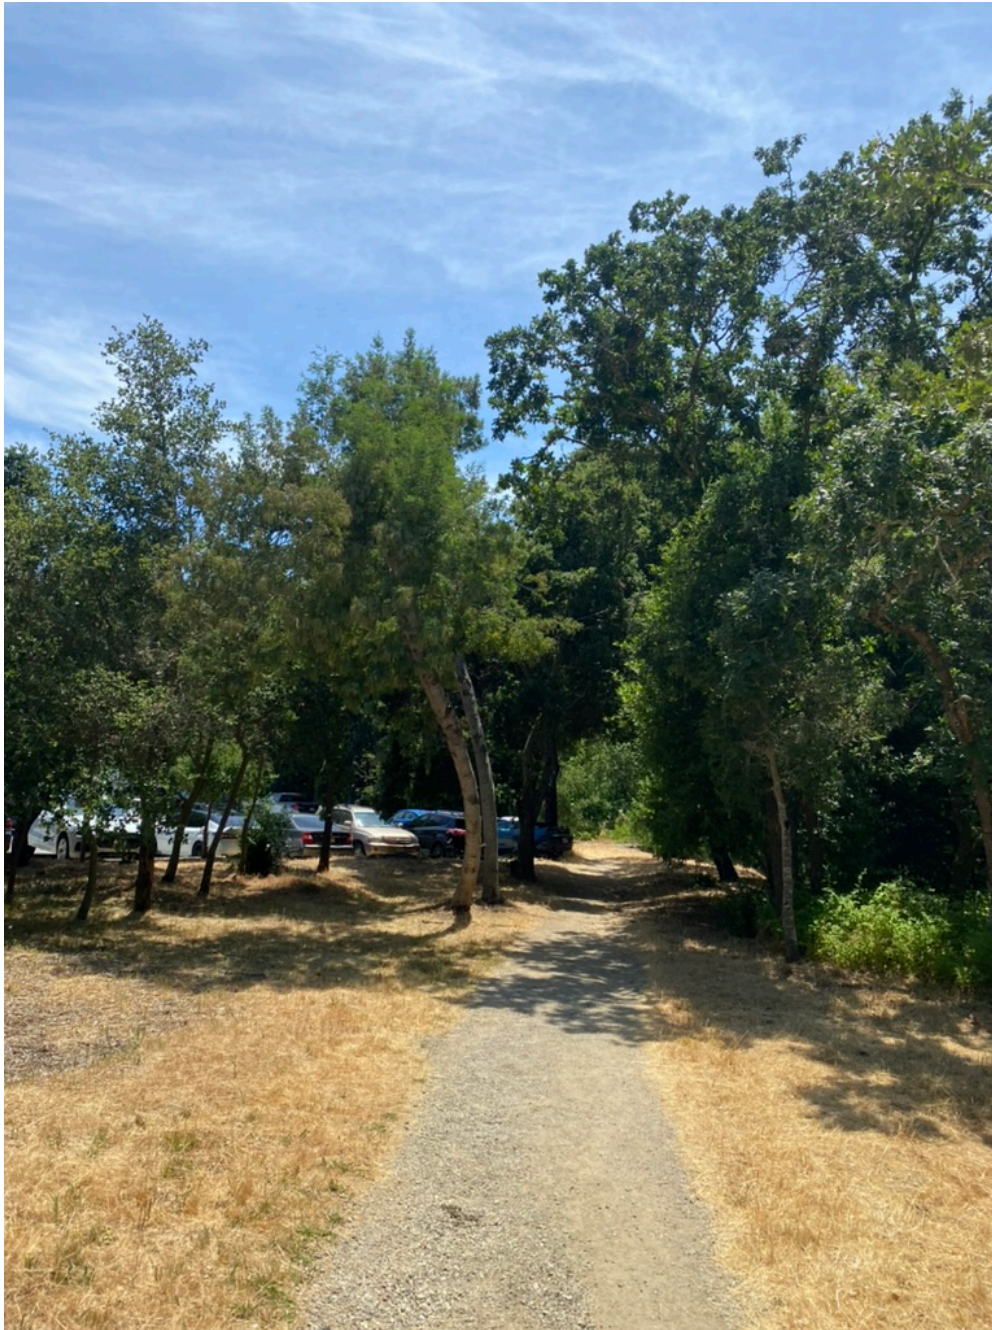
C2: Trees near existing lot to be removed

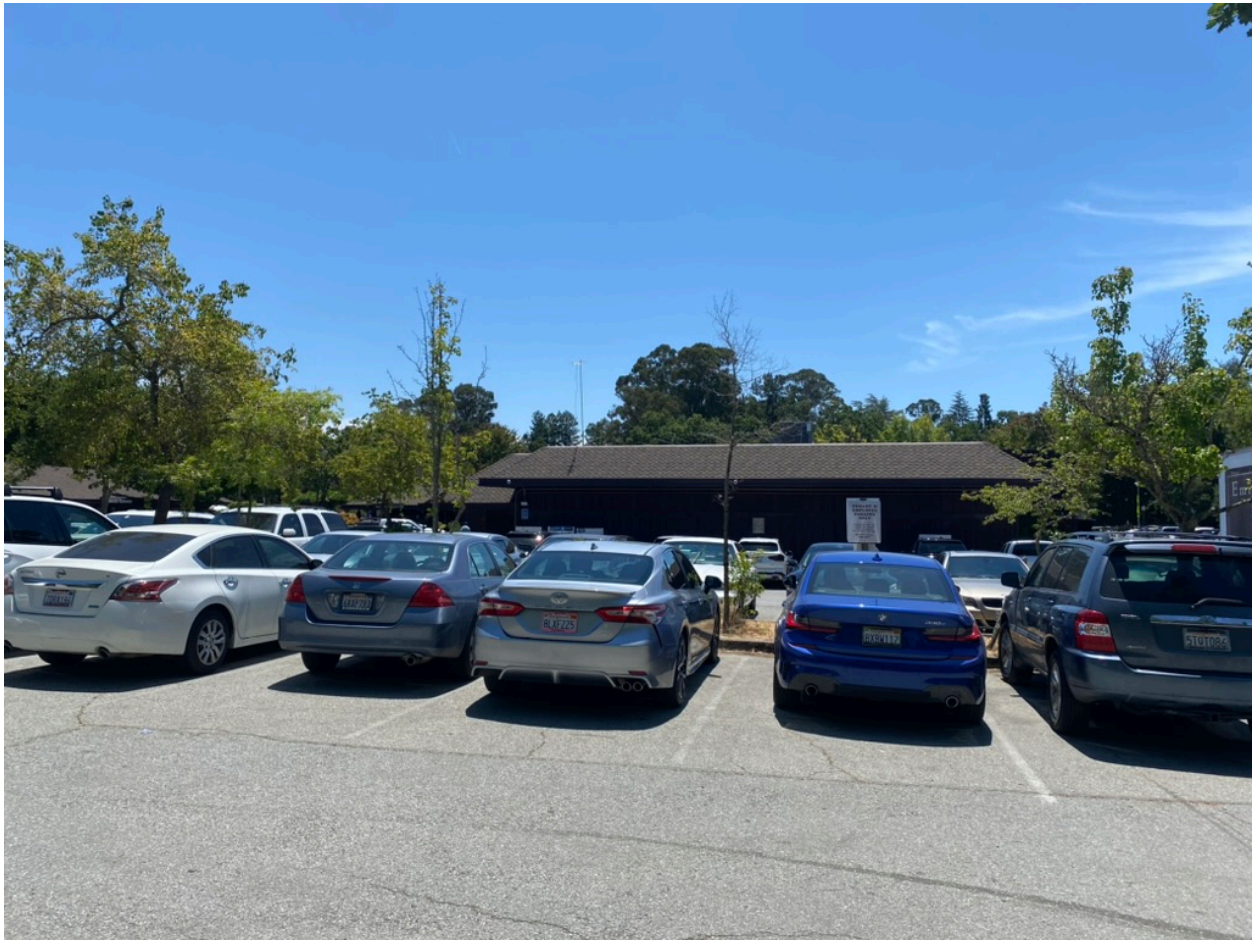
C3: Dead pears in parking lot island

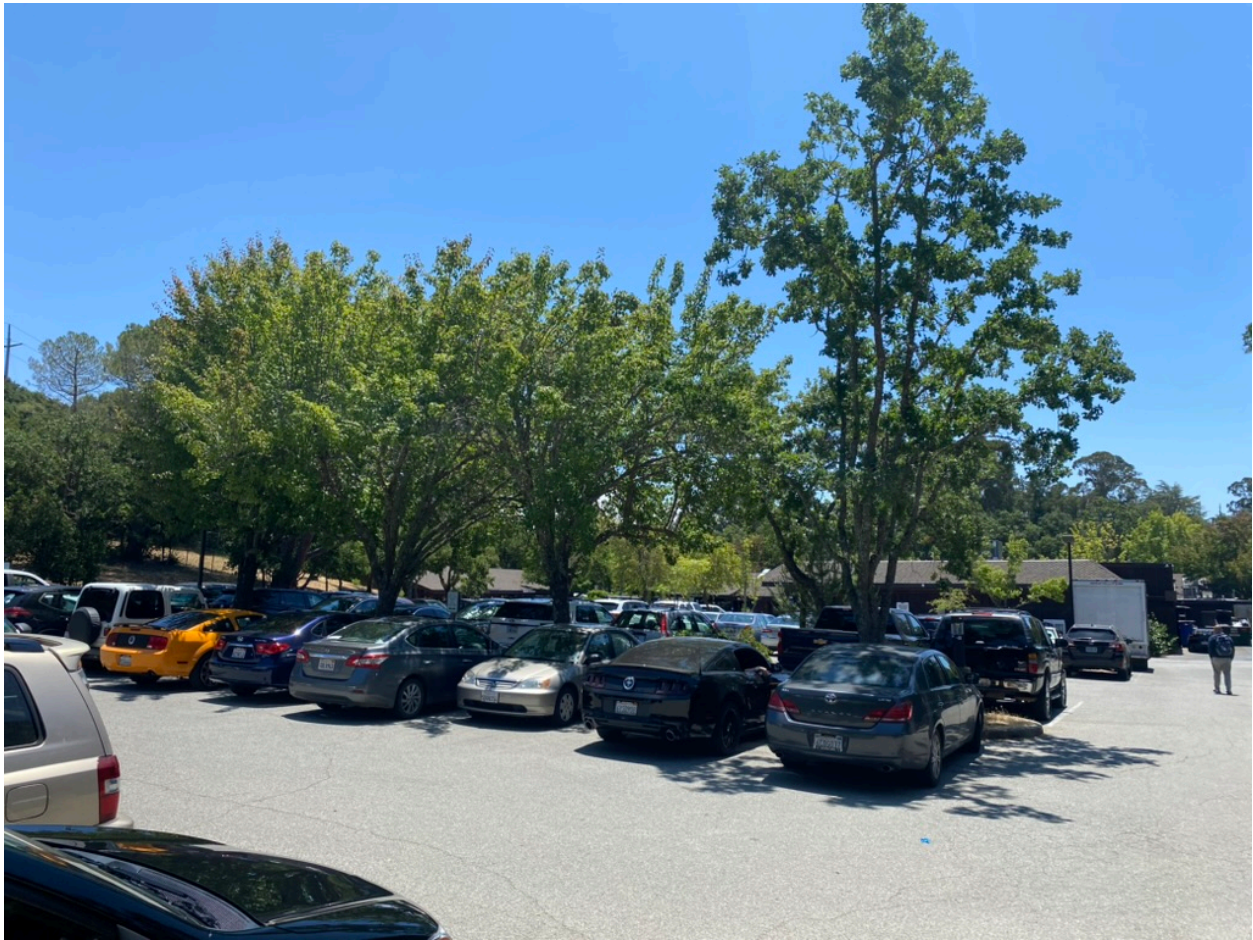
C4: Pears (and oak) to be retained in parking lot island

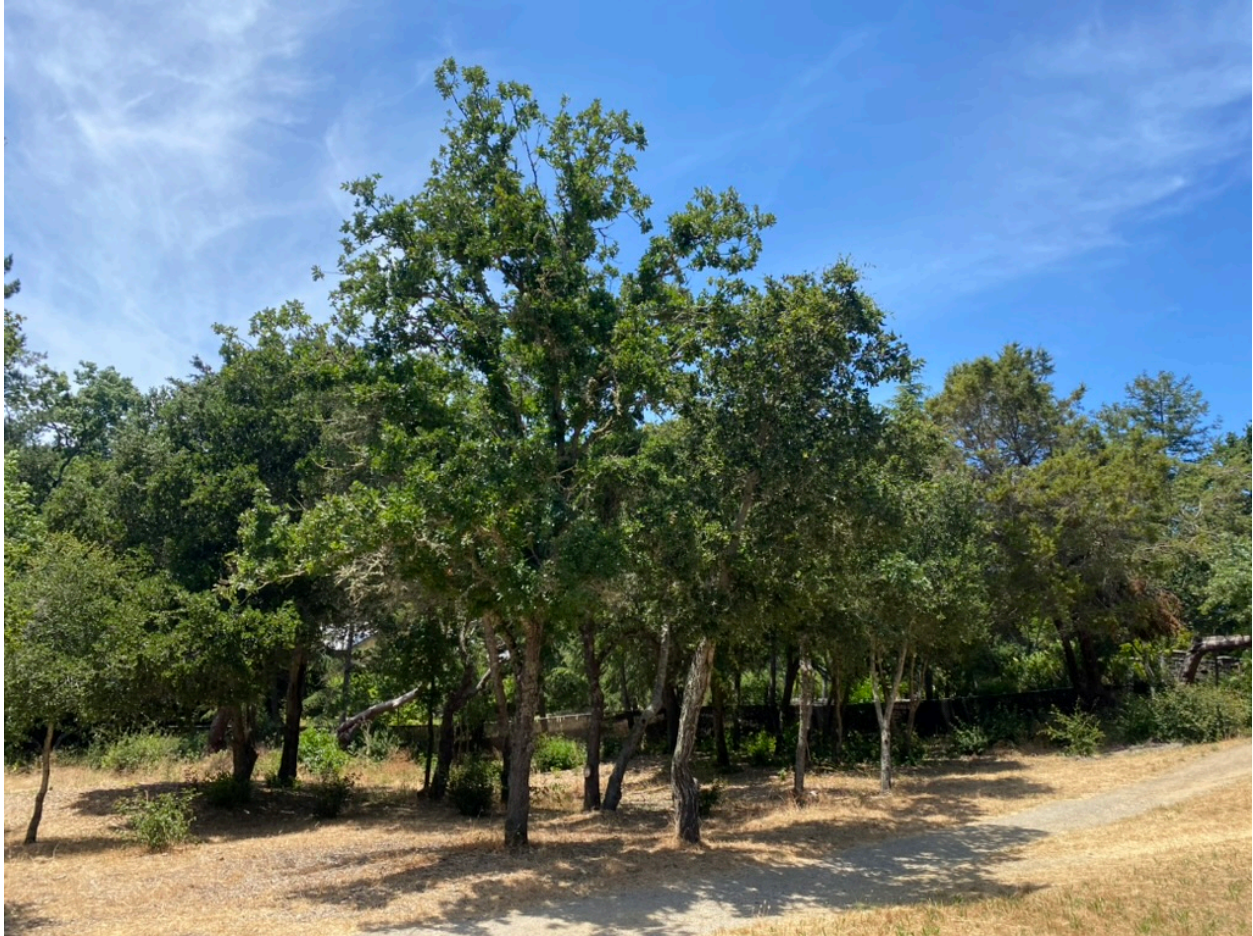
C5: Most of the trees at north end of proposed lot to be retained
